**DEFENDING DUNEDIN:  
THE ARCHAEOLOGY OF DUNEDIN'S COASTAL  
FORTIFICATIONS  
1885- 1945**

Alexander Scahill

A dissertation submitted in partial fulfilment of the requirements for  
Bachelor of Arts (Hons) in Anthropology  
University of Otago, Dunedin, New Zealand

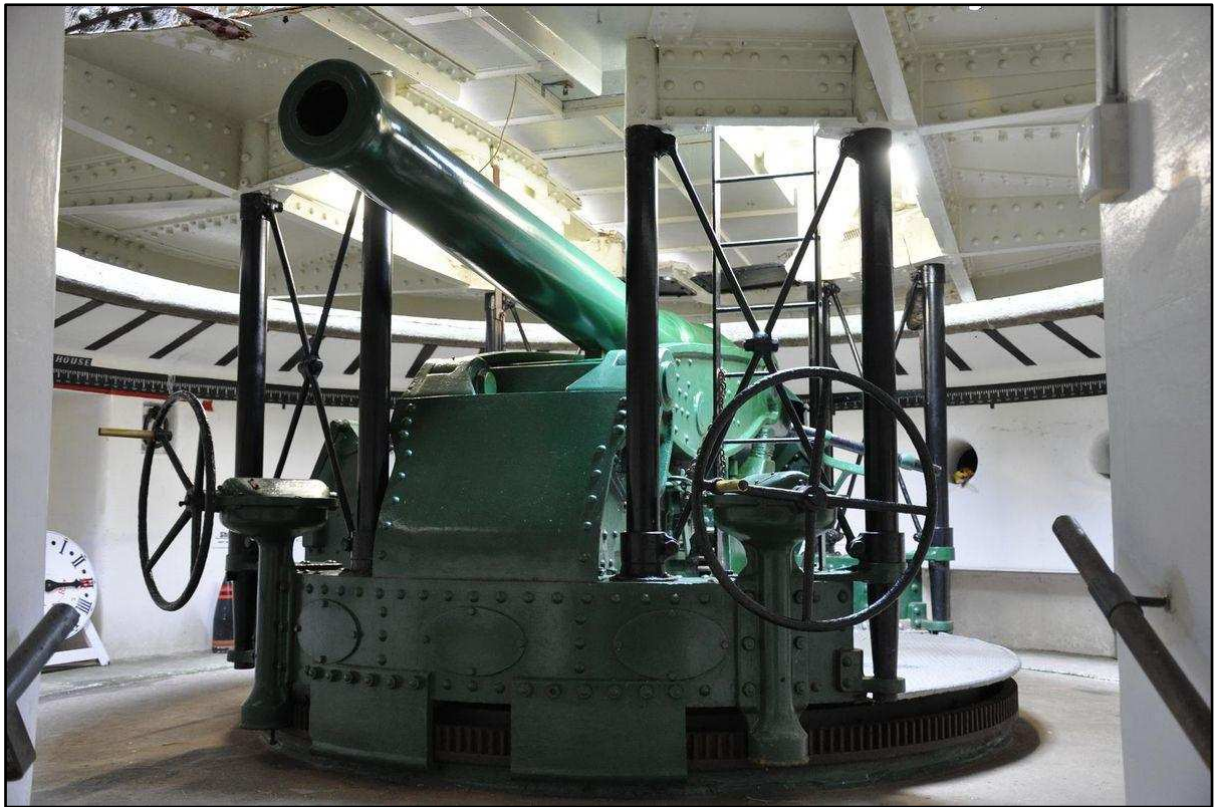
installation on the headland (Figure 4.). Installed in 1889, the Armstrong Disappearing gun was operational until 1920, and then again from 1941 to 1943. During the Second World War, the fifty year old gun was reconditioned, but by then was obsolete and only useful to protect against enemy landing, as its range was too limited to be useful against offshore bombardment (Cooke 2000: 250). At this point, due to its age, there were doubts as to the guns reliability, and tales tell of an anxious gun-crew diving for cover during test firing of the weapon (Stark 1965: 6). The intimidating nature of this gun echoes through to its after its restoration, reflected in the words of Morrie Hammond who, in a 1987 letter, refers to the gun affectionately as "Bertha" while stating "This monster frightened me." (Hammond 1987: 1- 4). The gun was only ever fired once in anger, during the Second World War when a fishing boat entering the harbour failed to observe proper protocols (Sorrell 1999: 695). Now restored, it is the only working example of this type of gun in the world (Historic Fort Taiaroa 2008) as all New Zealand's other examples were either dumped in Cook Strait or melted down to avoid being captured by the enemy in the event of an invasion (Heyward 1999: 13; Cooke 2000: 119). This gun was operated from an underground pit. It would be aimed while in the pit, then raised on its hydro-pneumatic mounting and fired. The recoil from firing would then push the gun back underground for reloading (Historic Fort Taiaroa 2008). Being underground, except when firing, such guns were virtually impregnable (Knight 1979: 30). Designed by W. G. Armstrong in England, the Disappearing guns each weighed 18.5 tonnes and cost a £14,000 each to install, a great expense considering 23 were ordered for New Zealand's various defences (Heyward 1999: 13).

Figure 4. Armstrong Disappearing Gun while underground (Photo courtesy of Royal Albatross Centre).

Hamel (1994: 4) notes that this battery has been constructed differently to the others. While the other batteries are constructed mostly of concrete, the Disappearing Gun emplacement has been built of carefully trimmed and mortared bluestone, with some sections of wall made of old bricks and with concrete floors. The bluestone construction extends through a downhill passageway 25 metres to the west and exiting through Tunnel Gate, a bluestone wall "elegantly finished with small posts and bolstered top stones" and an iron gate. Hamel states that the Tunnel Gate feature is one of the most attractive features at the site. The observation post associated with the Disappearing gun is made of concrete with a tin roof, while a hatch and ladder provided internal access to the gun (*ibid*). A new tunnel was also built in 1986 replicating the original construction, in order to maintain ease of access to the emplacement without disturbing the albatross (Cooke 2000: 119). Summit Battery, which was often viewed as a detached section of the Lighthouse Battery has now been removed and the area is now occupied by a bird viewing observatory (*ibid*). Active from 1888 until 1906, the battery was mounted with a 6-pound Nordenfelt Quick Firing Gun (J44/151).

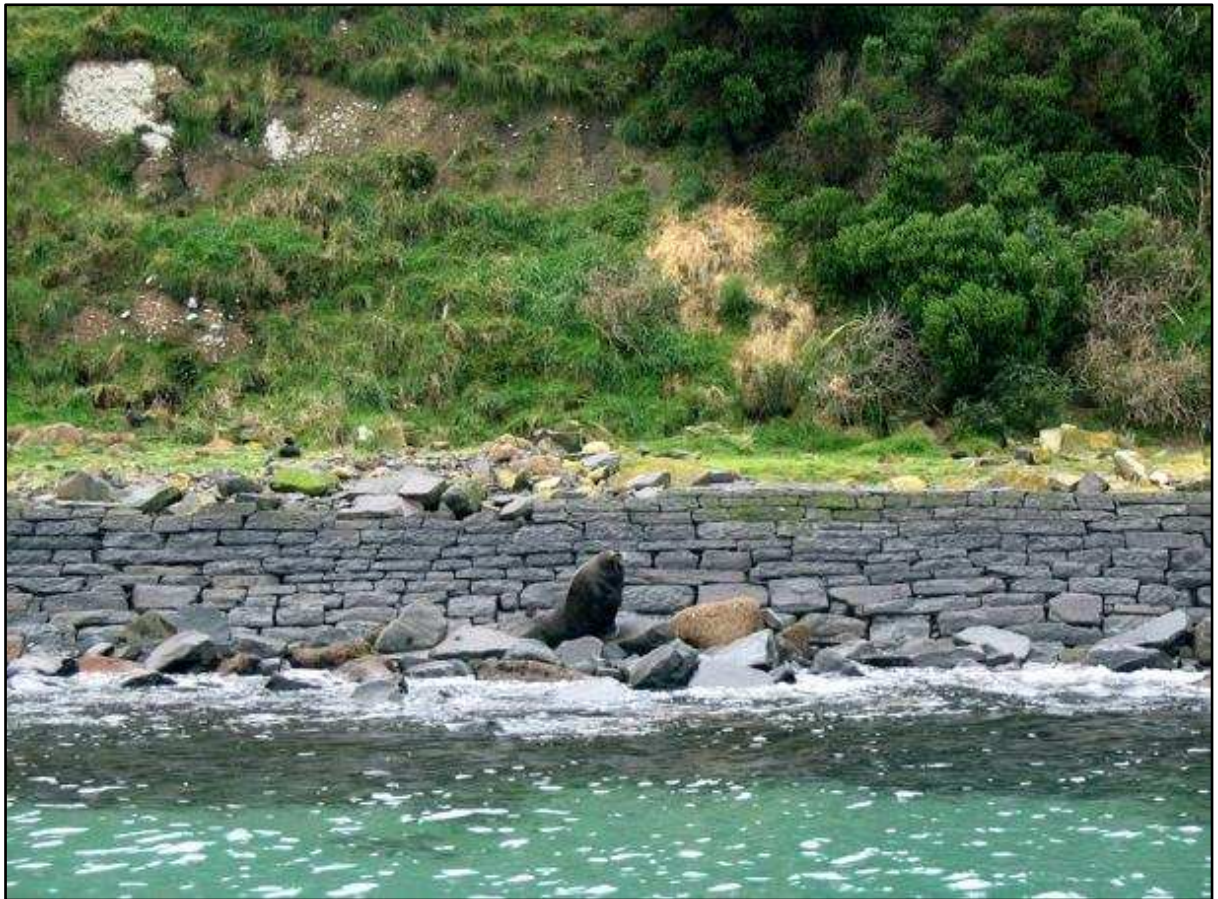
Figure 6. Stone jetty showing basalt blocks, and fur seal in foreground (Photo courtesy of Jill Hamel).

The stones are graded with the larger stones at the bottom (Hamel 1994: 2). The wall is about 2 metres high in most sections. Originally the jetty was paved with large stone slabs, although many of the slabs have now moved or been damaged due to forces placed upon them from waves and the tidal movement of the harbour (J44/148), with the most severe damage occurring at the

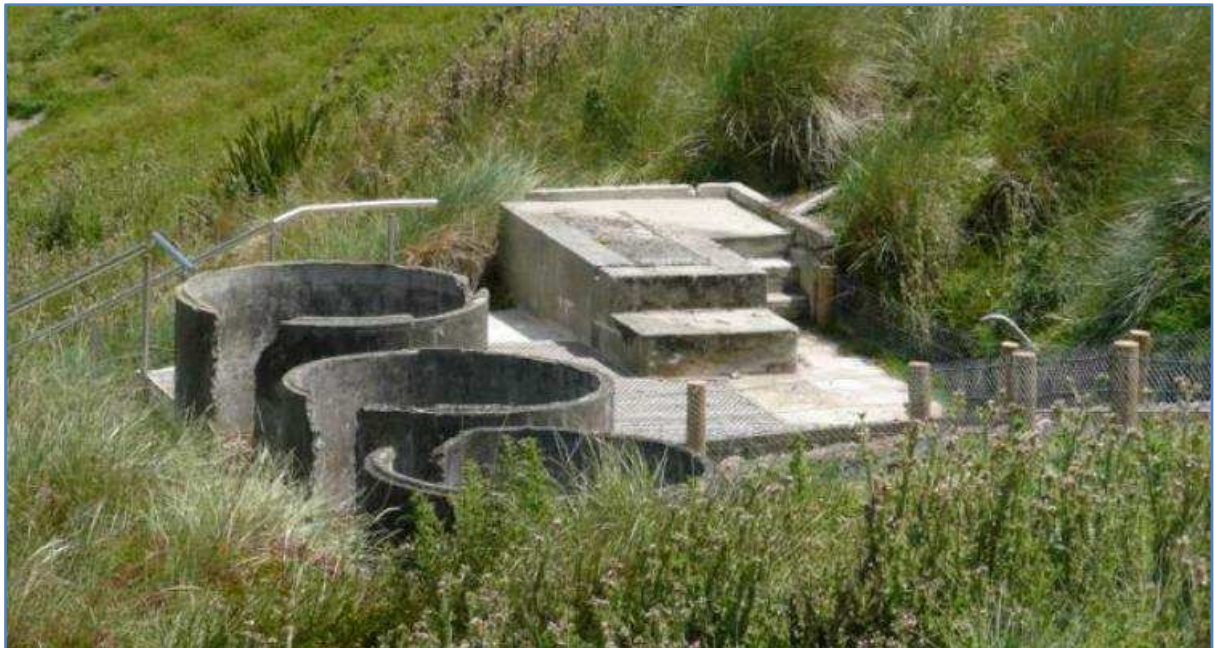
Figure 7. Water tanks and foundations of water pump house. Fort Taiaroa (Photo courtesy of Jill Hamel).

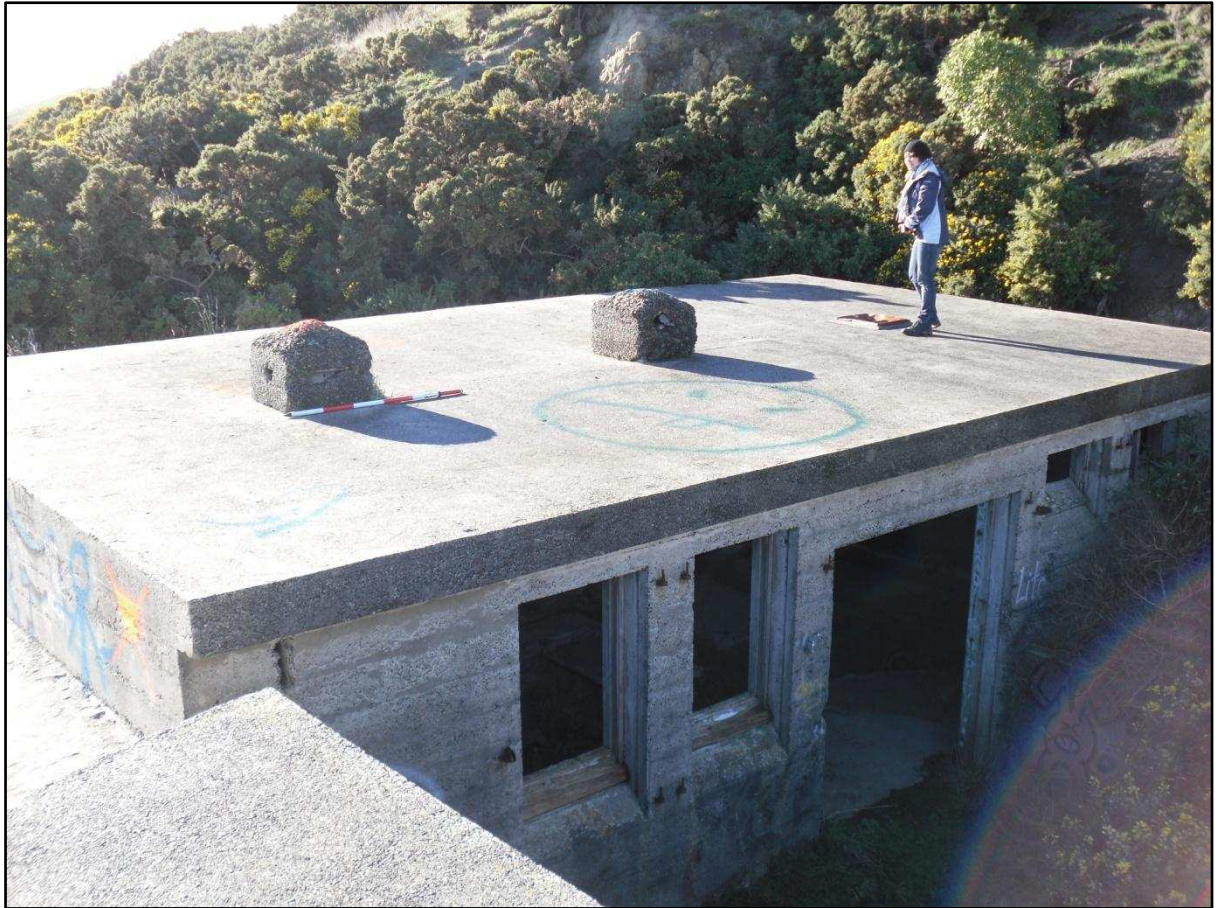
runs the length of the structures, only the top one metre of the building is above the natural surface level of the hillside. The building has been constructed using cement mixed with an aggregate of small stones approximately 0.5- 2cm in size. Horizontal seams varying from 10- 20cm apart indicate that construction was completed by pouring each concrete layer once the previous layer had set. On the roof of the structure there are three vents, set at equal distances apart running down the centreline of the roof. Two of these have square concrete boxes about fifty centimetres high, with small holes on each side for ventilation. The cement in these boxes has been mixed with a much coarser aggregate with stones between 2- 5cm. Portions of the concrete on these boxes has broken away, and small metal chimneys are visible underneath the concrete. The third vent has had the concrete box removed and is now just a square hole in the roof. On the northern wall of the structure there are also three ventilation units near the top of the wall. On the southern facing wall in the centre is a large doorway 2.15m high and 1.90m wide. The wooden doorway frame is still in place. To the left of this, when facing into the building are two window frames 1.10m high and 0.75m wide. These begin at the ceiling and extend down. To the right of the doorway are four window frames, each measuring 0.55m high and 0.90m wide. Two of these are at ground level, while the other two are directly above at ceiling level. The wooden frames on all but one of the windows are still in place. Beside the door and all the windows, metal hinges and latches indicate where the door and window covers were once attached.

**Figure 10. World War II Engine Room at Harington Point, complete with budding archaeologist.**

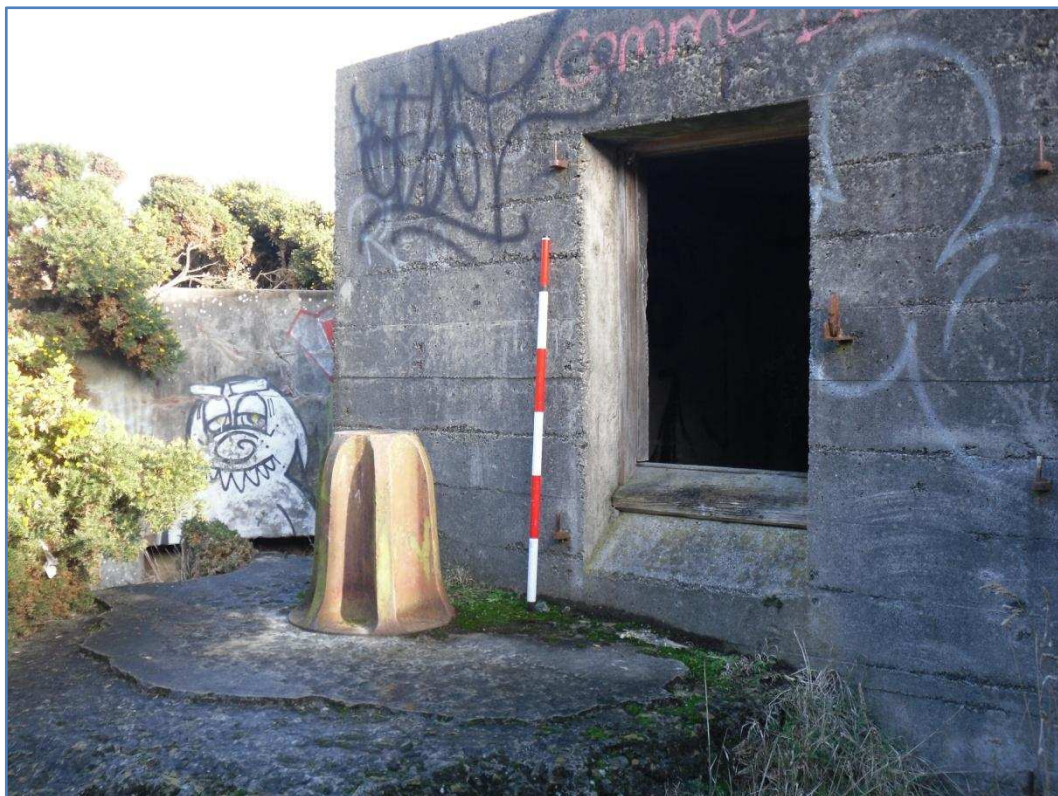
Directly beside the northern engine room are the structural remains of a 7-inch Rifled Muzzle Loader (RML) gun emplacement. This consists of a rounded concrete wall, and half-hemisphere shaped building 2.9m long by 4.0m wide. The building is a single room and has several small boxes built into the wall at ground level. Approximately 1m above ground level there are boxes built into the wall 0.3m high and 0.15m wide, and spaced approximately 1.5m apart. As the rounded wall continues past the building these boxes continue in the exterior wall. Each of these small boxes has a single large chain link fixed into the concrete. These were likely used as additional braces for the emplaced gun. On the exterior of the building on the eastern side is a circular raised concrete platform approximately one metre high. This has pieces of railway iron protruding from the broken edges, evidence of strengthening. In the centre of this raised platform is a large circular metal platform 0.50m wide and 0.60m high. This is the base of where the 7-inch gun would have been placed (Figure 11.). Across the western side of both the engine room and the gun emplacement at surface level runs a flat concrete lip, which connects the two structures.

Figure 11. 1890s 7-inch RML Gun Emplacement at Harington Point.

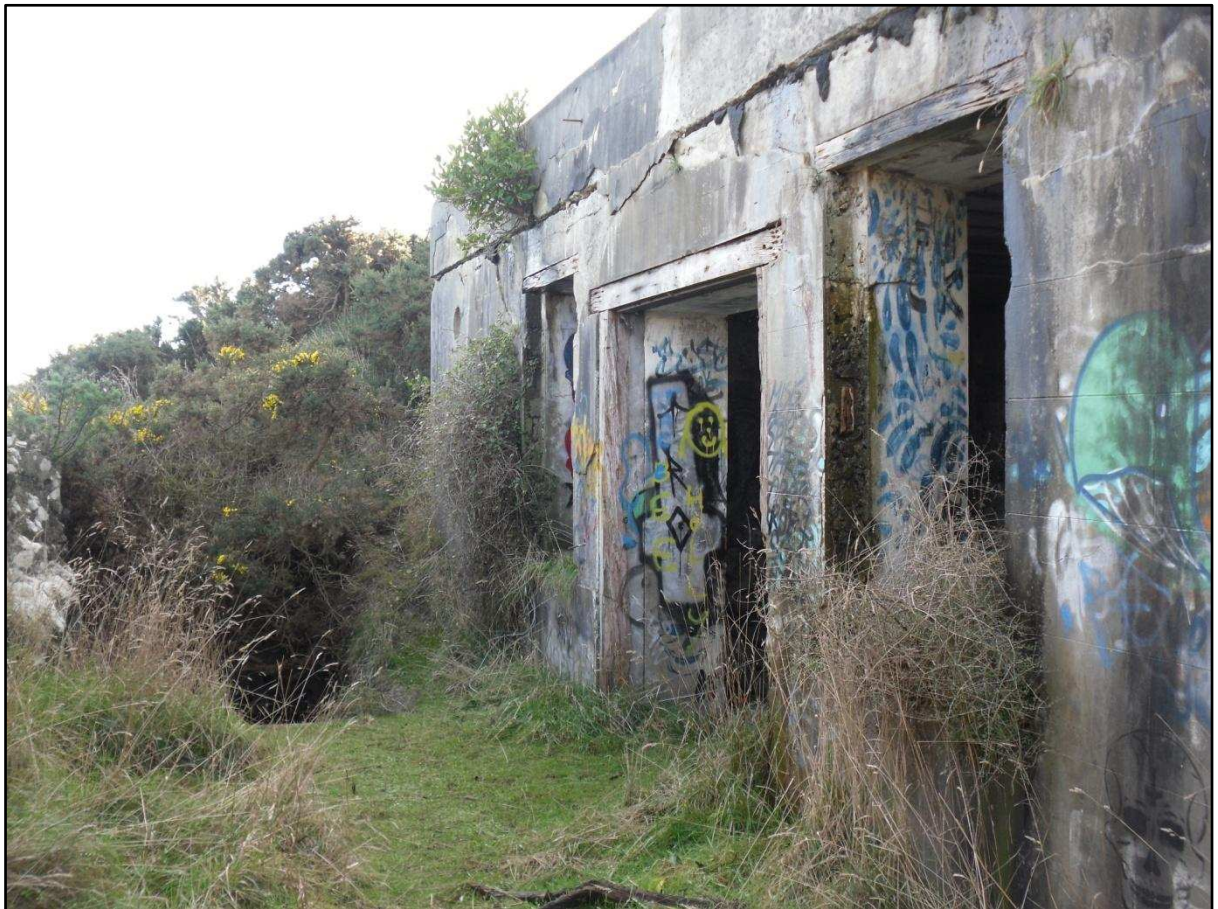
**Figure 12. 1890s Engine Room. Facade has partially deteriorated, revealing concrete construction underneath.**

Inside the structure, the ceiling is concrete, with metal beams roughly 5cm wide running the from north to south. These beams are spaced roughly 30cm apart and continue the whole length of the building. It is likely that the roofing concrete was poured into sections with the metal beams before being placed on top of the walls and secured using the asphalt layer. Inside the engine room the floor is concrete, but in places has broken away, revealing a second layer of concrete with wooden panels. In the centre of the room is a raised concrete platform 2.50m long by 1.10m wide with metal bolts in each corner. Similarly to the northern engine room, there are three ventilation holes in the ceiling at regular intervals. The internal walls at the western end of the building have decayed a lot, revealing the coarse aggregate underneath the smooth concrete exterior. Not visible where the smooth exterior still remains, in this decayed section there are the exposed ends of wooden beams in the walls, spaced roughly 40- 50cm apart horizontally. The top row of these is just below roof level, and there are further rows directly underneath at intervals of roughly one metre. Interestingly, this same end of the building is where the concrete floors have broken away to reveal the wooden panels underneath. From the way the southern facade is open, the western end of the building would be more exposed to harsh southerly weather conditions, possibly explaining the greater deterioration seen in the western end of the building. In the centre of the eastern wall at

1880s engine room bears significantly more deterioration in the concrete of the internal walls at the western end of the structure, which is more exposed to the harsh conditions of a southerly weather front than the eastern end of the walls. Underground structures at the site, such as the tunnel and magazine complex, being protected from weather, exhibit minimal signs of deterioration. As access to Rerewahine was not possible due to safety concerns, the condition of structures was not witnessed firsthand, but levels of deterioration are reportedly quite extreme at this site, significant enough to compromise the structural integrity of the buildings (Stewart, L.: pers. comm.). Without surveying the site, and with a lack of official reports pertaining to the site, it is difficult to attribute particular causes to the high level of deterioration at this site. However, considering the good condition that the majority of the other sites are in, it is highly likely that human factors have contributed to the increased rate of decay seen here. The only other site reported to be highly susceptible to deterioration is the Channel Battery and old stable at Fort Taiaroa, which was severely damaged by intentional demolition attempts and by a bulldozer, compromising the integrity of the archaeological remains (Hamel 1994: 2- 3).

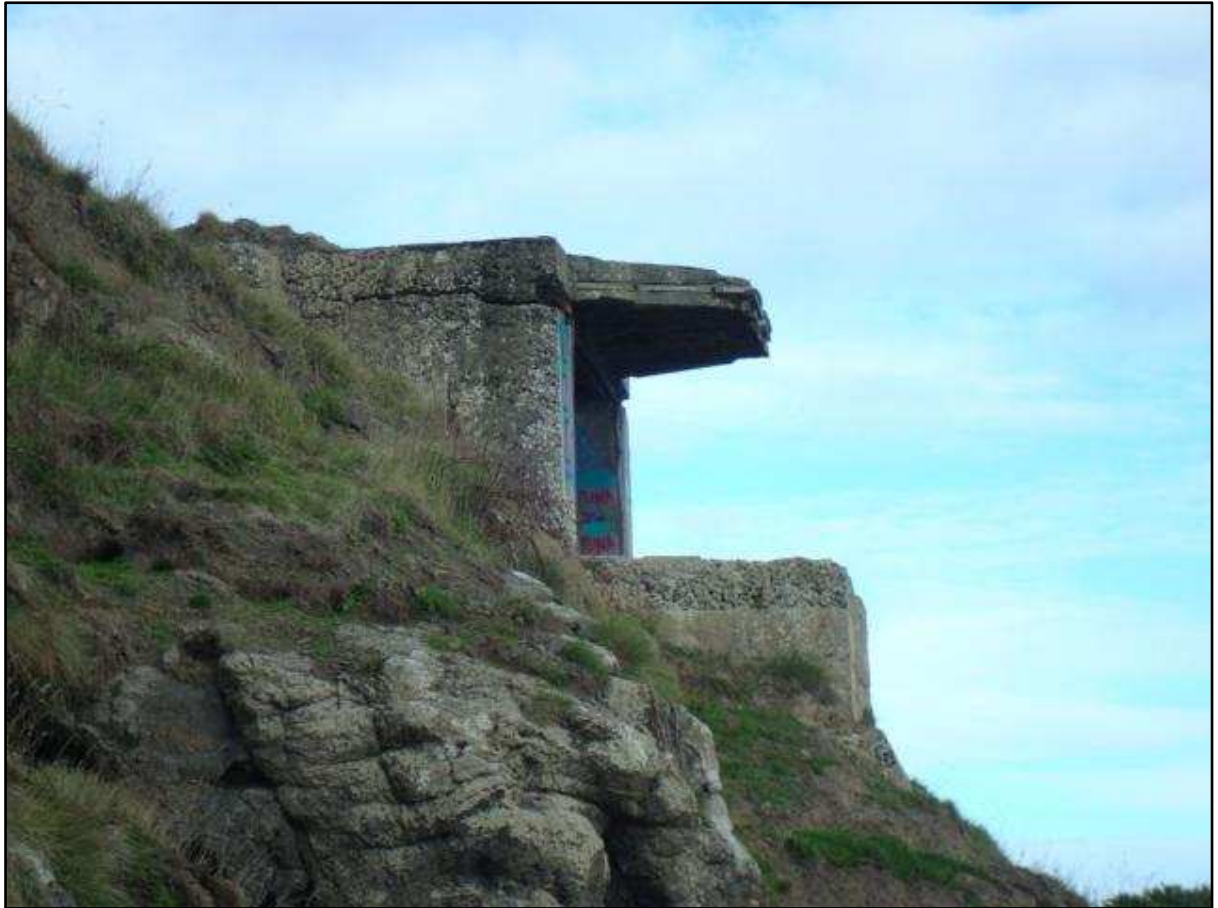
The oldest structure at this level is the southernmost searchlight post, completed in 1906 (Fort Record Book n.d.: 17). In 1941, searchlight emplacement was installed with three railway locomotive headlights, which were powered by six volt batteries (Fort Record Book n.d.: 17). However these were not installed long before being upgraded in 1942 to Coastal Artillery Lamps with 90cm 3° dispersal projectors, powered by a Ford V8 engine coupled with a Holmes D.C. generator (*ibid*). This structure is located on the rocky cliffs overlooking the shoreline (Figure 13.). As with the other structures at the complex this searchlight post, measuring 5.8m long by 4.1m wide, is constructed from concrete with a coarse aggregate 5- 10cm in size, covered in a smoother exterior layer. Much of the exterior layer has broken away, exposing the core aggregate material. The floor of this structure is concrete, but is now covered with a thick layer of mud washed downhill through the tunnel. Externally, the roof has been covered with a layer of asphalt about 2cm thick. Unlike the engine room which had this material as a layer between the roof and walls, the searchlight structure has the layer spread across the rooftop. Near the western end of the building there is a small ventilation hole. On the north-eastern corner of the building the concrete has been broken away in several places, creating several small holes which pass through the entire thickness of the wall.

Figure 13. 1906 Searchlight Post at Harington Point.

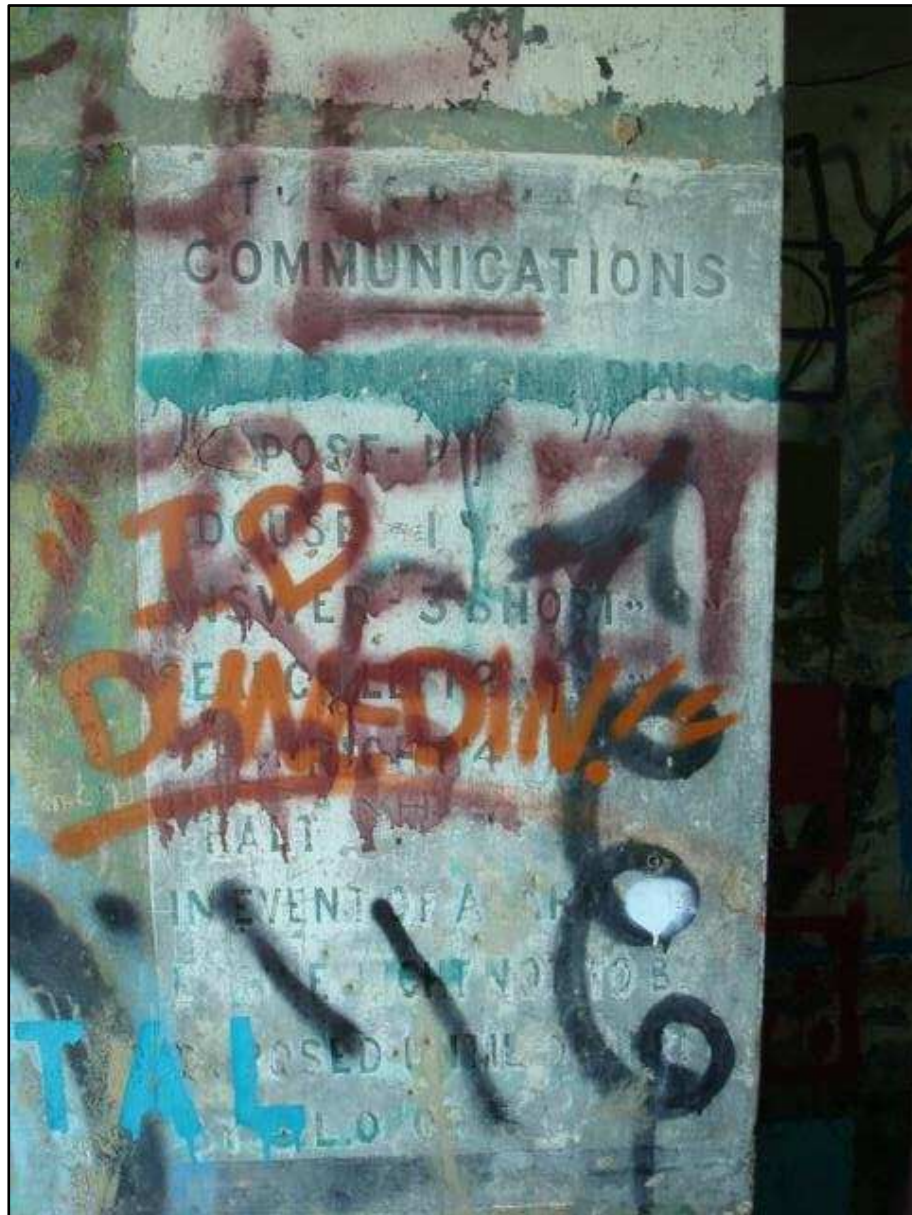
Internally the walls of this structure exhibit the same horizontal seams evident on the northern engine room and gun emplacement at the upper level. The ceiling is strengthened differently from the other buildings at the site. Like the 1880s engine room, the concrete in the ceiling of this searchlight post is strengthened by using metal beams roughly 5cm wide. In the eastern half of the building these beams are spaced similarly to the engine room, approximately 30cm apart, running widthways across the structure. However, on the western half of the structure there is a much higher incidence of these beams, with a divide of only 3 - 4cm, and the beams run perpendicular to those on the eastern half of the structure. Near the western end of the structure there are also two thick railway sleepers concreted in to support the roof. On the northern wall, near the western end there are the partially legible remains of some original communications instructions painted on the wall, though graffiti has meant the sign cannot be fully read (Figure 14.). Beside this is a small box built into the wall, presumably some sort of storage. At the south-eastern end of the

structure the tunnel branches off to the south, heading uphill toward the engine room. A wooden frame with hinges still present indicates the tunnel was once sealable with a door.

Figure 14. 1906 Searchlight Post communications instructions partially legible on wall.

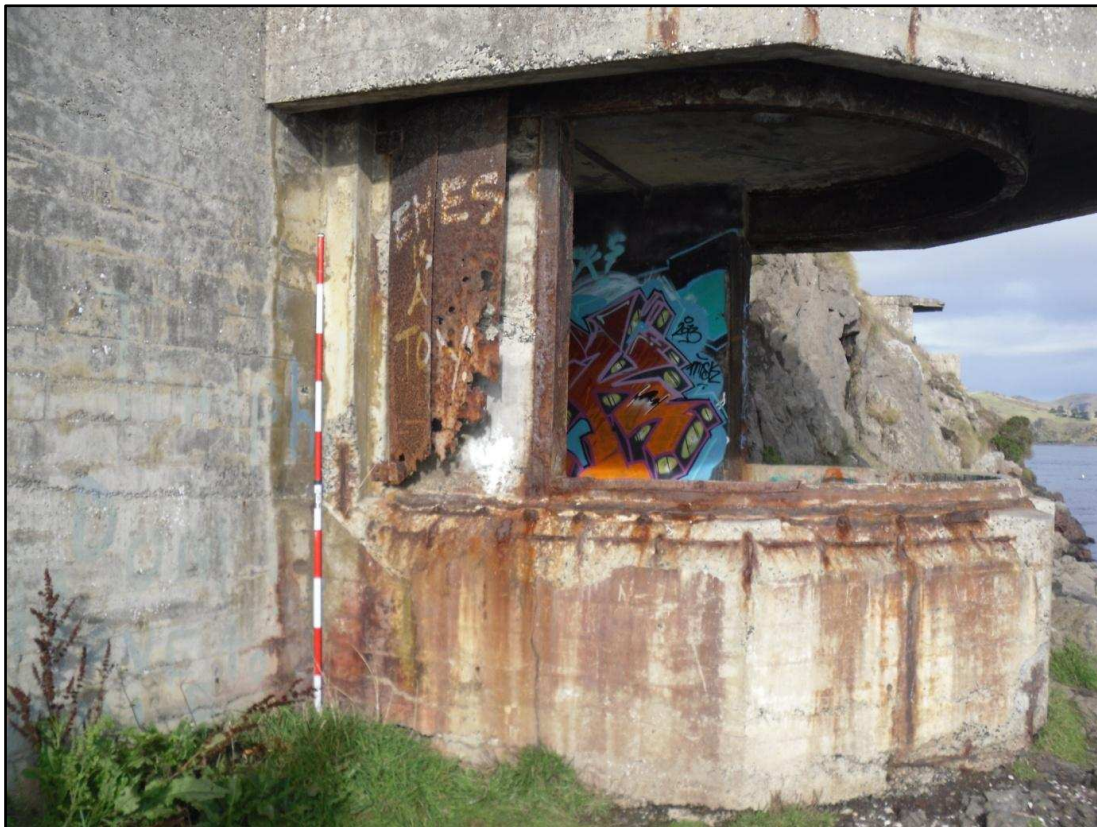
materials to the other structures at the site. The building measures 6.15m long, at the front is 4.15m wide, and at the rear is 5.15m wide. This extra width accounts for the entry room discussed below. At the western end of this searchlight post, the roof concrete overhangs slightly to create a sort of lip. Inside of this there is a semi-circular concrete wall roughly 1m high with a metal rim. There is a corresponding metal rim attached to the ceiling with what appears to be a metal track. At each end of this, where the semi-circle wall joins with the rectangular building, attached to the wall are the remnants of large metal shutters on hinges. It is likely that at the time of use these metal shutters would have extended around the semi-circle to close in the building, with the shutter able to slide open along the metal tracks installed in the ceiling. Running from the rear of the room (eastern end) to the front down the centre is a track cut onto the concrete, possibly used to slide the searchlight back and forth. There is a smaller square room built at the north eastern end of the structure, and entry to the building is via the rear end. The roof of this structure appears to have been made in a single large slab, with no evident seams like those exhibited in other structures.

Figure 15. World War II Searchlight Post at Harington Point.

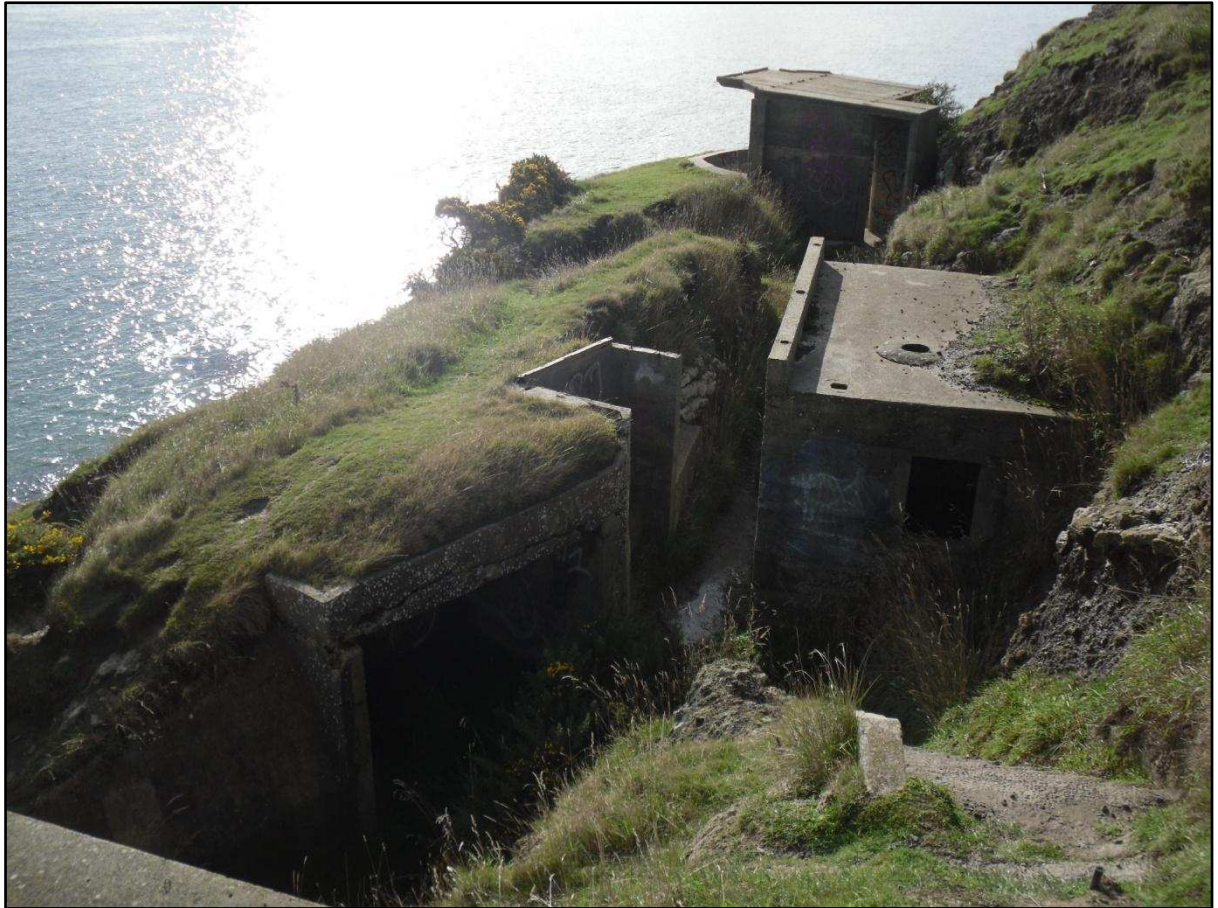
There are two Quick Firing Gun emplacements on the lower level (Cooke 2000: 84). In February 1941 these were mounted with two 15-pound Quick Firing guns (Fort Record Book n.d.: 45). Deemed obsolete, the placement of these guns was short-lived and after a matter of only about nine months these were removed and replaced with two 6-pound Nordenfelt Quick Firing guns (*ibid*; Cooke 2000: 84), while the 15-pounders were sent to Central Battery (Fort Record Book n.d.: 33). These emplacements were built in order to provide counter-attack against small hostile vessels moving through the narrow harbour entrance (*ibid*.: 7), and covered a range from 210° extreme left to 010° right (*ibid*: 16). The right side of the arc faced directly towards Fort Taiaroa. These two structures have been made like the other structures at the site, with coarse aggregated concrete. The difference between these two buildings and the others lies in the roof construction. The roofs of these two structures are comprised of six concrete panels 0.60m wide running east to west. Each of the panels has a large metal bolt protruding at both the western and eastern end. Both the walls and roofs of these structures have been strengthened by using 1cm thick metal rods, which have been set in a woven fashion inside the concrete, and are only visible now due to decay. The two Quick Firing emplacements both have small boxes built into their rear walls. These measure 1.05m wide, 0.90m high, and 0.90m deep, and closely resemble the two square boxes found in the northern World War II era engine room in the upper level. These recesses were used for the storage of ammunition (Fort Taiaroa Archive FT00/207 n.d.: 511- 512). Hamel (1994: 3) describes similar features within Howlett Point Battery at Fort Taiaroa, and also speculates that those were likely for the storage of ammunition. The two buildings are similar in size. Both structures measure 3.5m long by 3.65m wide. However, the northern structure has a small entry way at the rear in the southern corner, while the southern structure has its entrance in the rear in the northern corner.

Figure 16. Harington Point lower level. Northern QF gun emplacement is visible in background, while corner of southern QF emplacement is visible in bottom left corner of photo. The war shelter is visible in between the two QF emplacements.

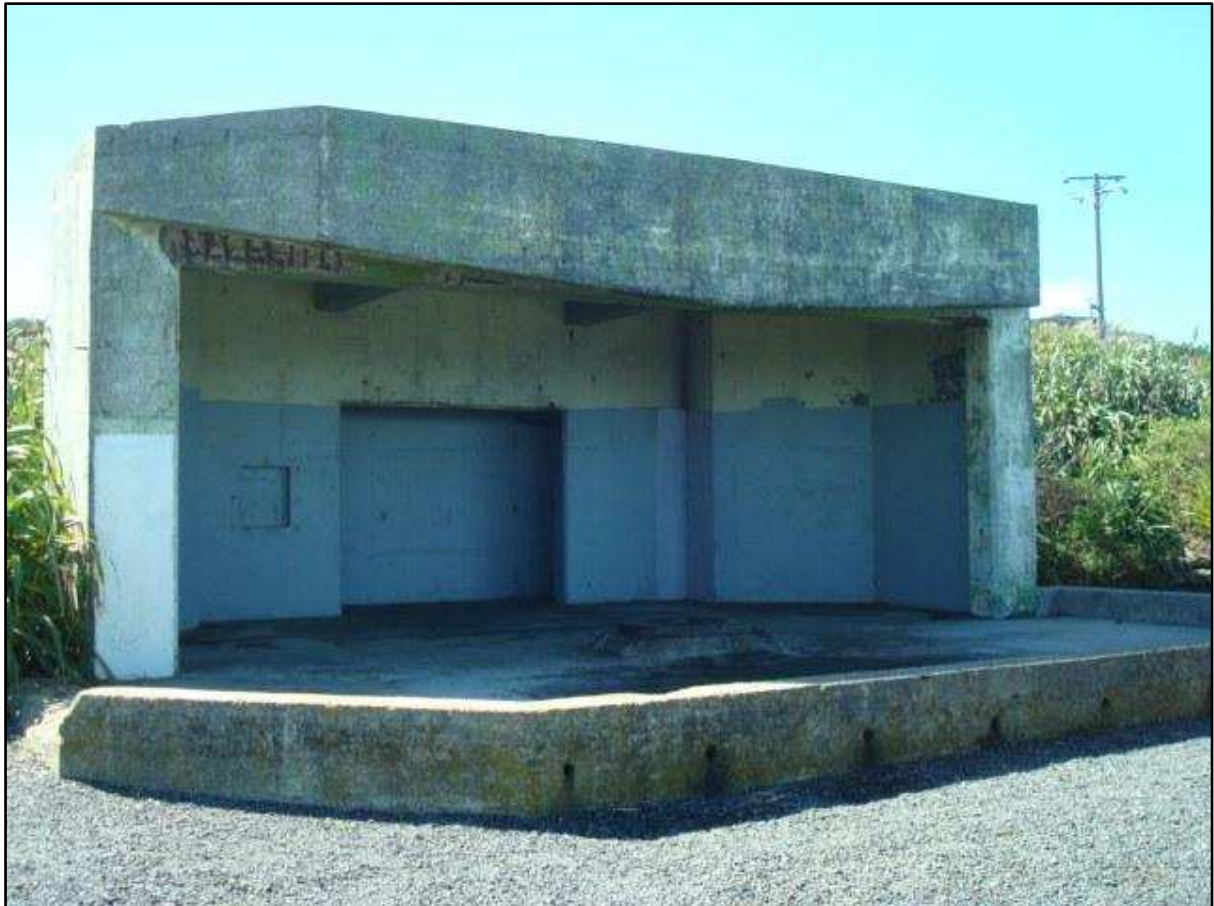
mountings 1.05m in diameter, set into the concrete. In the rear section of the structures were internal magazines, accessible through a wide doorway at the rear of the canopied area. The doorways into these rooms have large metal doors. In July 1945 both guns were removed from their mountings, the magazines were emptied, and the internal rooms of the emplacements were permanently sealed (Joyce 1995: 3; Cooke 2000: 498).

**Figure 18. Tomahawk 6-inch Gun Emplacement. Minimal deterioration can be seen in upper left section of canopy with metal reinforcement revealed from within the concrete.**

the Second World War structural evidence of reinforcement is only visible in areas of the structures that have suffered from deterioration, where the surface of the concrete has broken away and revealed the core of the walls and roofs. In these areas thin metal rods are visible within the core of the structures. It is possible that this method was also utilised in the structures built during the Russian scare although metal rods are not visible within any of the deteriorated patches of these older buildings.

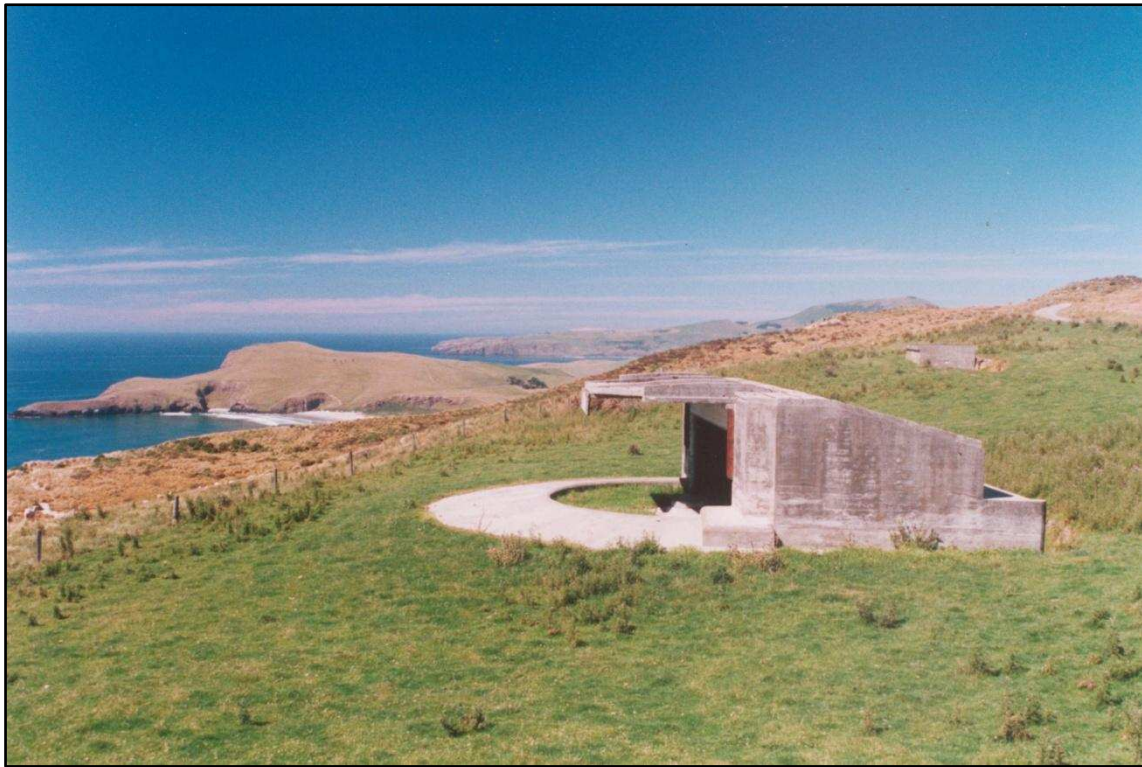
Figure 20. 6-inch gun emplacement at Rerewahine Battery. Second emplacement is visible in background. c. 1985. Condition of structures now is reportedly poor (Photo courtesy of Laurie Stewart, Otago Peninsula Trust).

Archaeologically, all concrete structures still remain in place, though these are in varying conditions. The site is on privately owned land, and the battery magazine has been modified in some capacity by the landowner (Cooke 2000: 496), while other structures have been utilised for the owners present business ventures (Stewart, L.: pers. comm.). Only one of the wooden barrack blocks is still standing (Cooke 2000: 496). Reportedly, many of the remaining concrete structures are in poor

condition, with the concrete deteriorating to such an extent as to make many of the structures unstable (Stewart, L.: pers. comm.). Due to the instability of the site and the resulting safety concerns, this site was inaccessible for survey as part of this project.

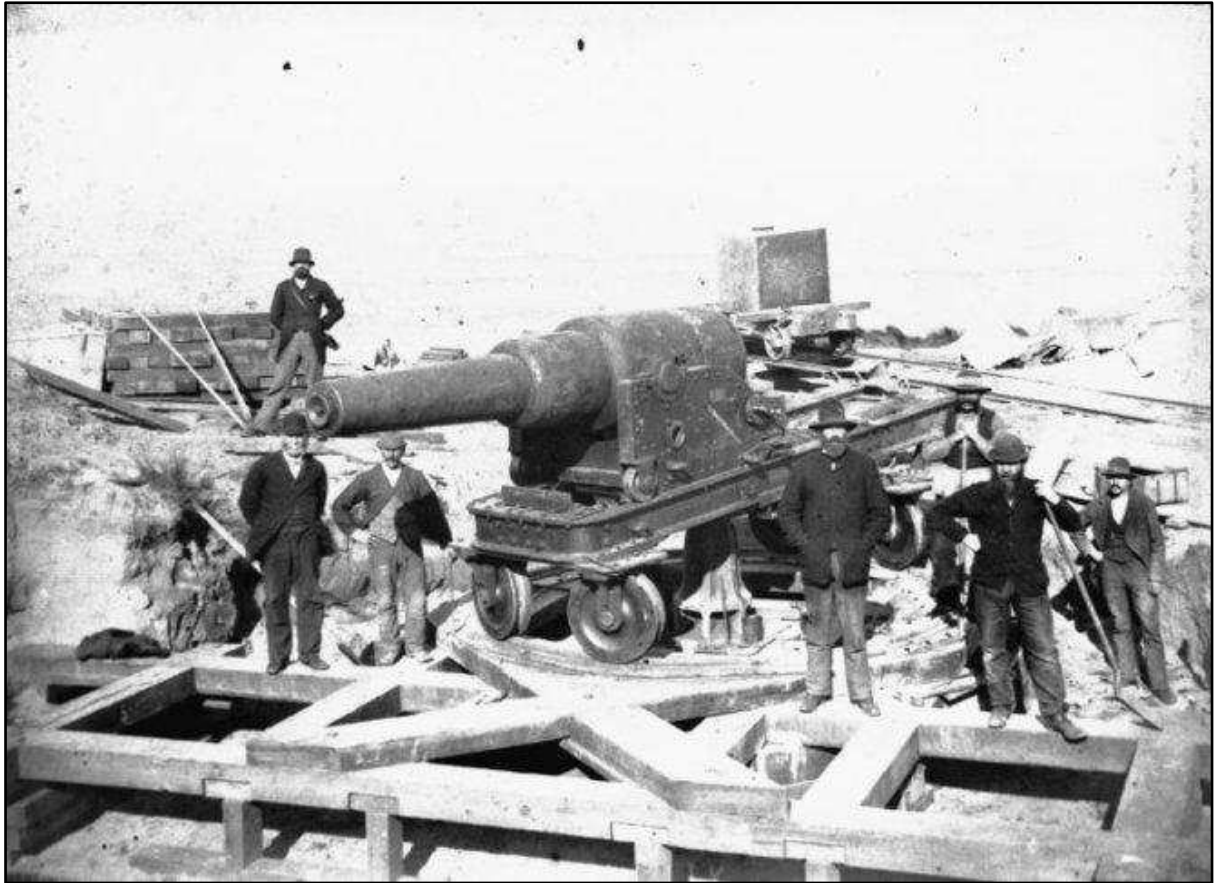
Constructed in 1885, Lawyer's Head Battery was mounted with a 7-inch 7-ton RML gun (Cooke 2000: 96) (Figure 21.). Official recommendation argued for the additional mounting of an 8-inch gun, but upon its arrival at the battery it was placed in storage and never mounted. The gun spent sixteen years in storage at the site before finally being removed and shipped to Wellington (*ibid*). The Lawyer's Head 7-inch gun, while covering beach landings at St. Kilda and St. Clair to the west, could also be pivoted to cover both offshore bombardment, and Ocean Grove and Tomahawk Beaches to the east (Stark 1965:5). The gun was removed twelve years after installation in 1897 (Cooke 2000: 96). The battery itself was of timber and earthwork construction (*ibid*).

Figure 21. Coast defense gun known as Keep-'em-off, Lawyer's Head, Dunedin. c. 1885. Field family: Field and Hodgkins family photographs. Ref: 1/2-105940-F. Alexander Turnbull Library, Wellington, New Zealand. <http://natlib.govt.nz/records/23056557>

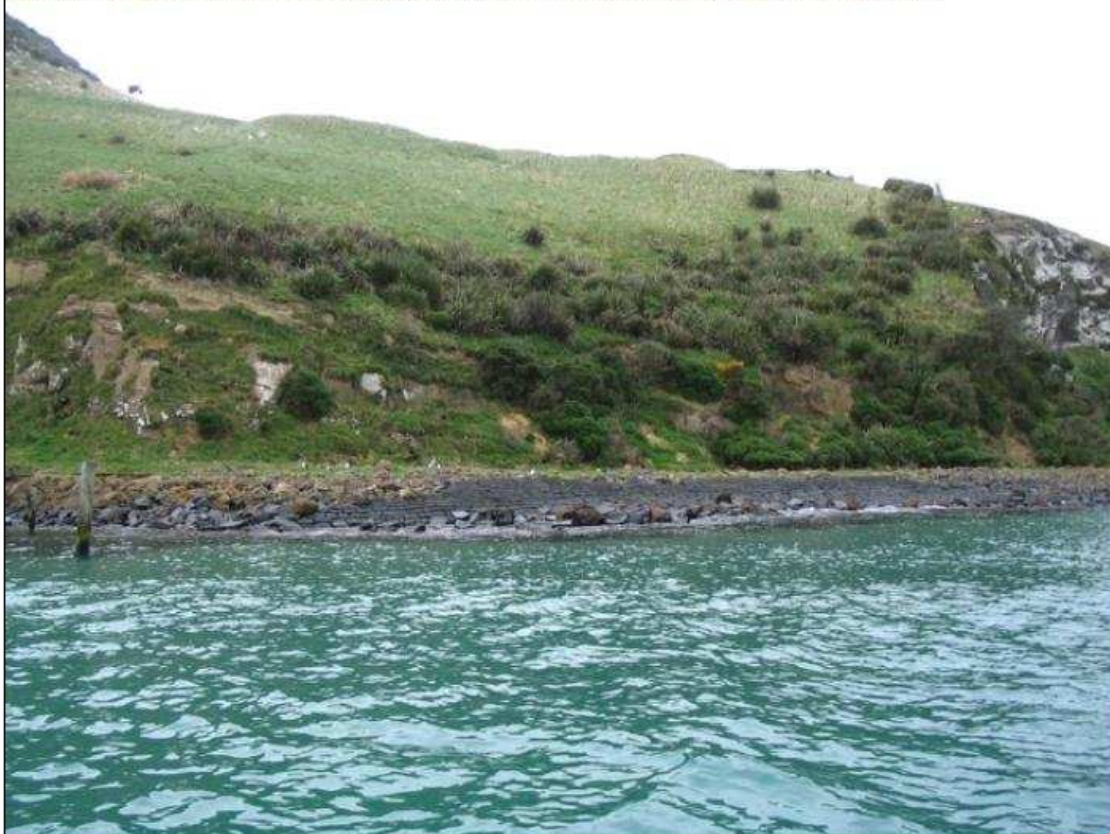
J44-148. Tarewai Point wharf close in - a fur seal bull has woken up (Jill Hamel, 2011).

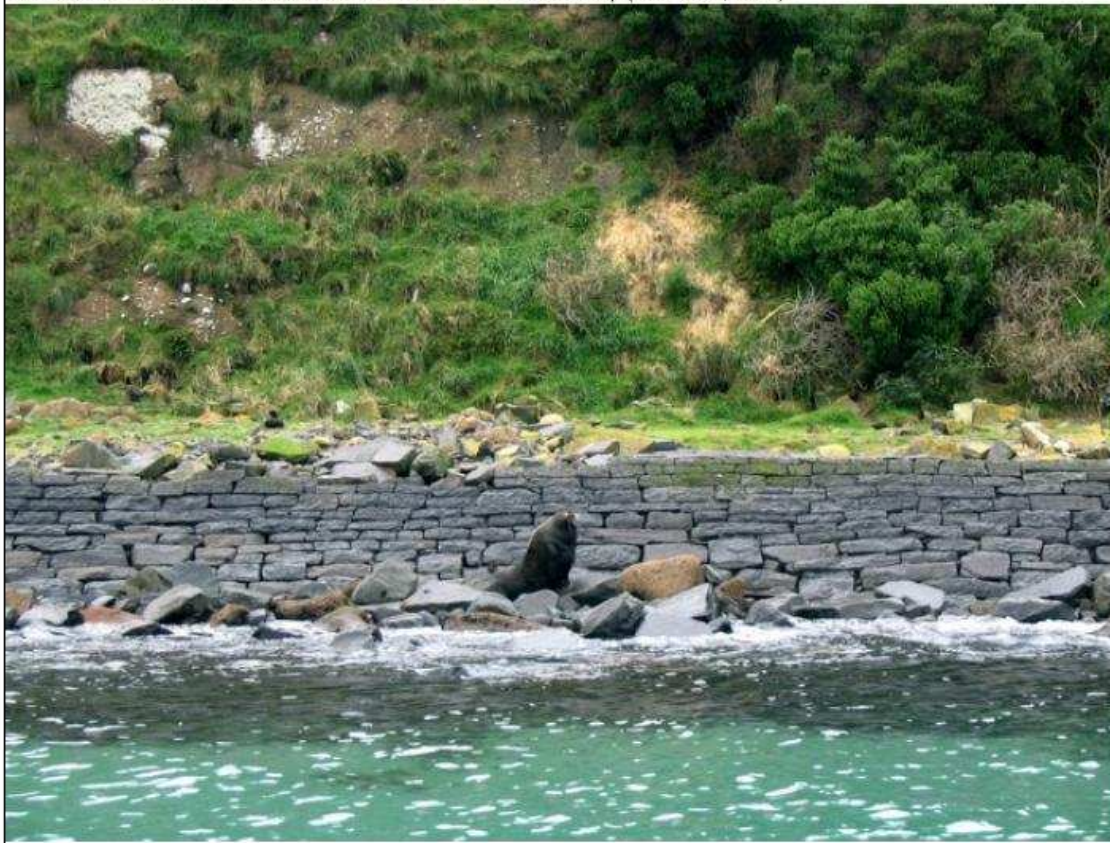
J44-148. Far right of Tarewai Point wharf where the sanctuary fence crosses it. The hand built walling has broken up at left but is still partially complete as it runs towards Pilots Beach (Jill Hamel, 2011).

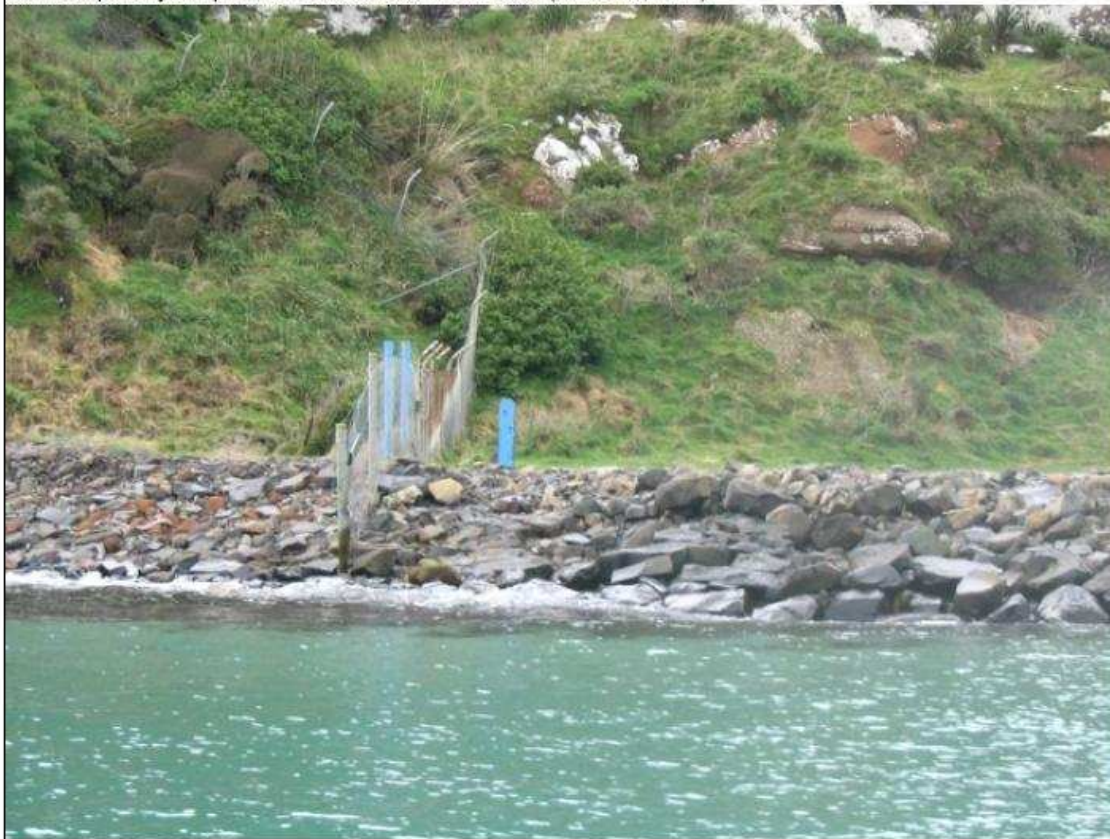
J44-148. Continuation of walling from the wharf into Pilots Beach. The tram line for hauling the guns ran just behind the track at the top of the photo (Jill Hamel, 2011).

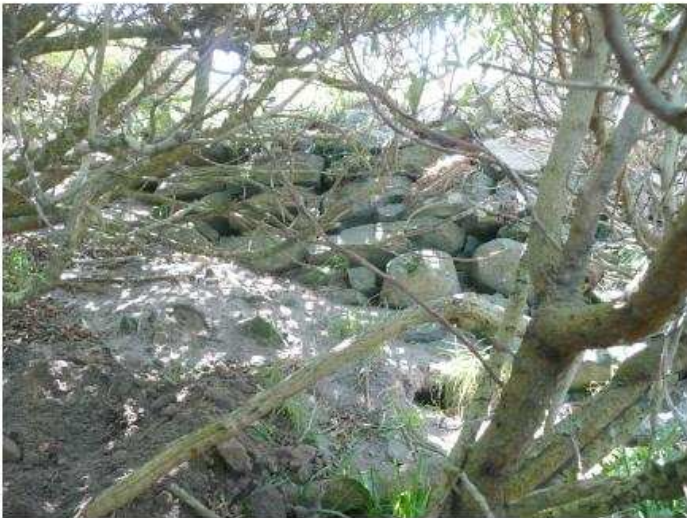
| 2. State of site and possible future damage<br>This was always a poorly built revetment and the ngaio over it are both sheltering and slightly displacing it. | | | |
| 3. Description of site (Supply full details, history, local environment, references, sketches, etc. If extra sheets are attached, include a summary here)<br>This is a short length of revetment on the sandy slope west of the road. It is 2-3 m long, less than 1 m high at the best, and built of rounded and slabby basalt rocks. It would have provided a small stable platform immediately above on the slope. It is just to the east of the main trench running downhill for the rails that ran up from Pilots Beach, and may have been associated with it. | | | |
