**DEFENDING DUNEDIN:  
THE ARCHAEOLOGY OF DUNEDIN'S COASTAL  
FORTIFICATIONS  
1885- 1945**

Alexander Scahill

A dissertation submitted in partial fulfilment of the requirements for  
Bachelor of Arts (Hons) in Anthropology  
University of Otago, Dunedin, New Zealand

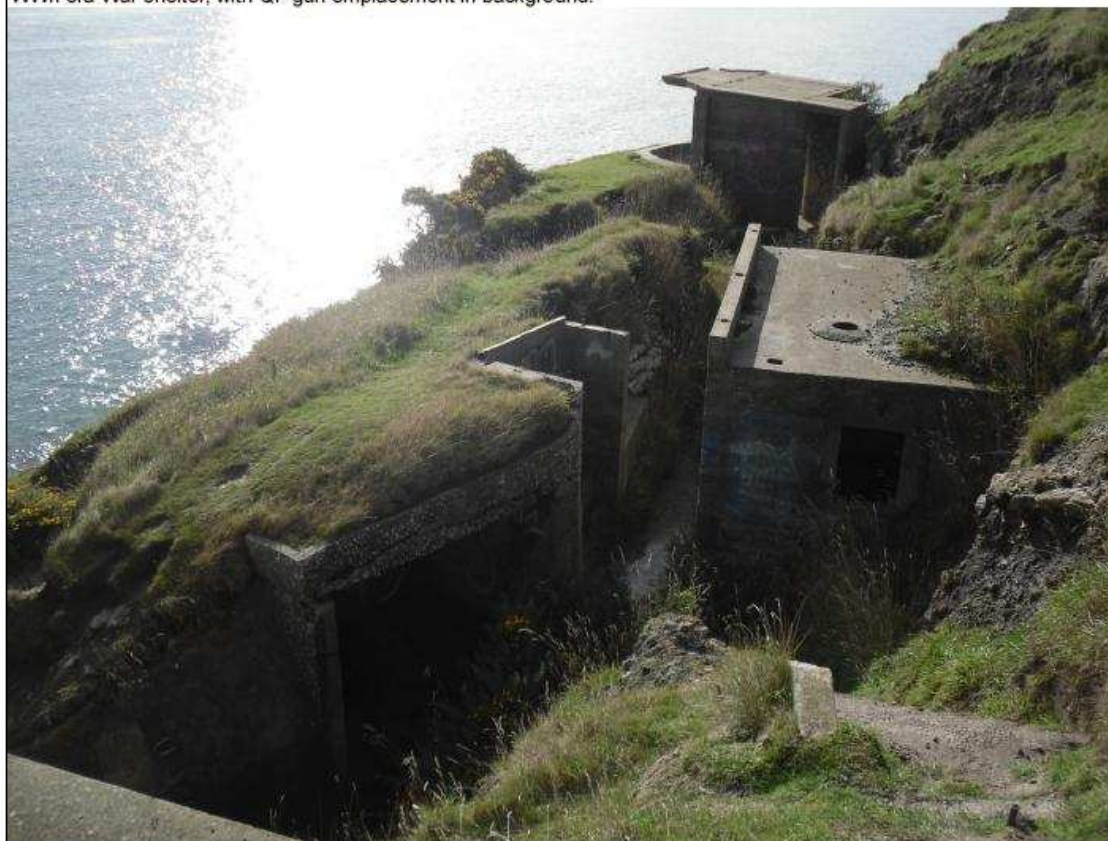
1890s Engine room. Deteriorated front facade reveals concrete construction underneath, disguised to appear as if constructed of large stone blocks.

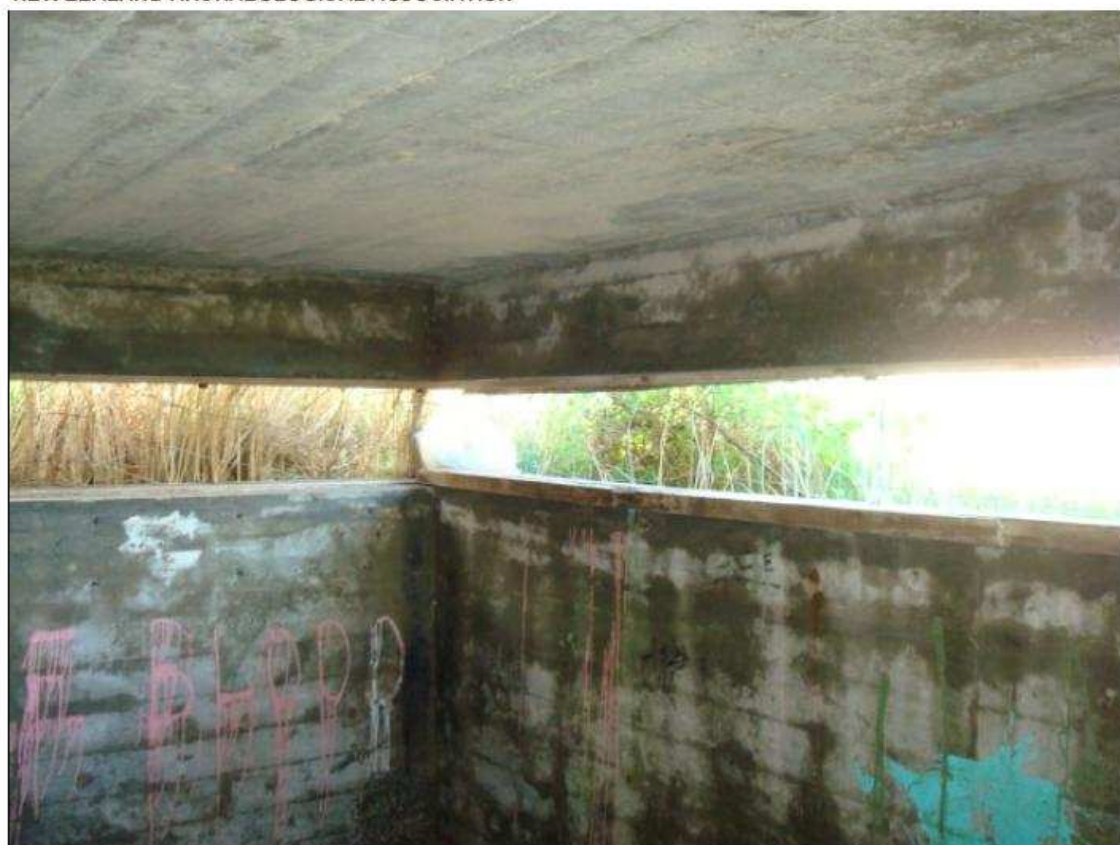
| Inside of Observation Post at Tomahawk Battery | | | | |

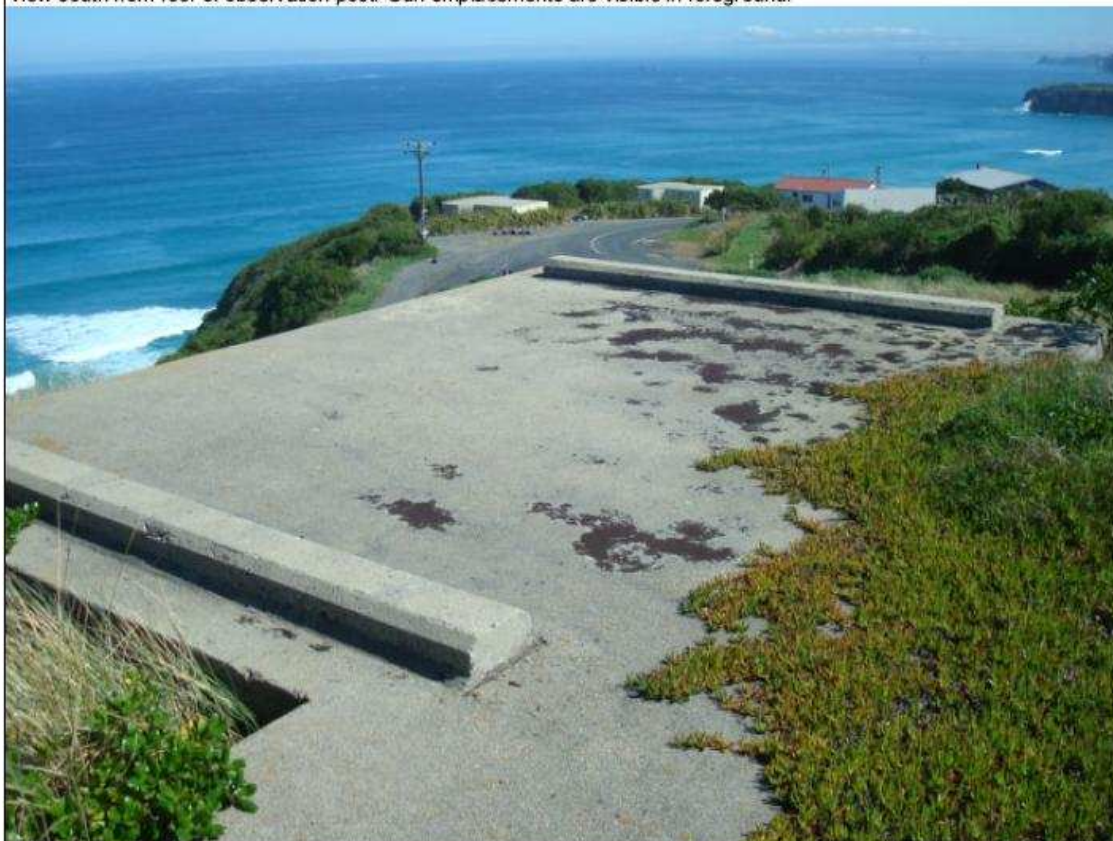
View south from roof of observation post. Gun emplacements are visible in foreground.

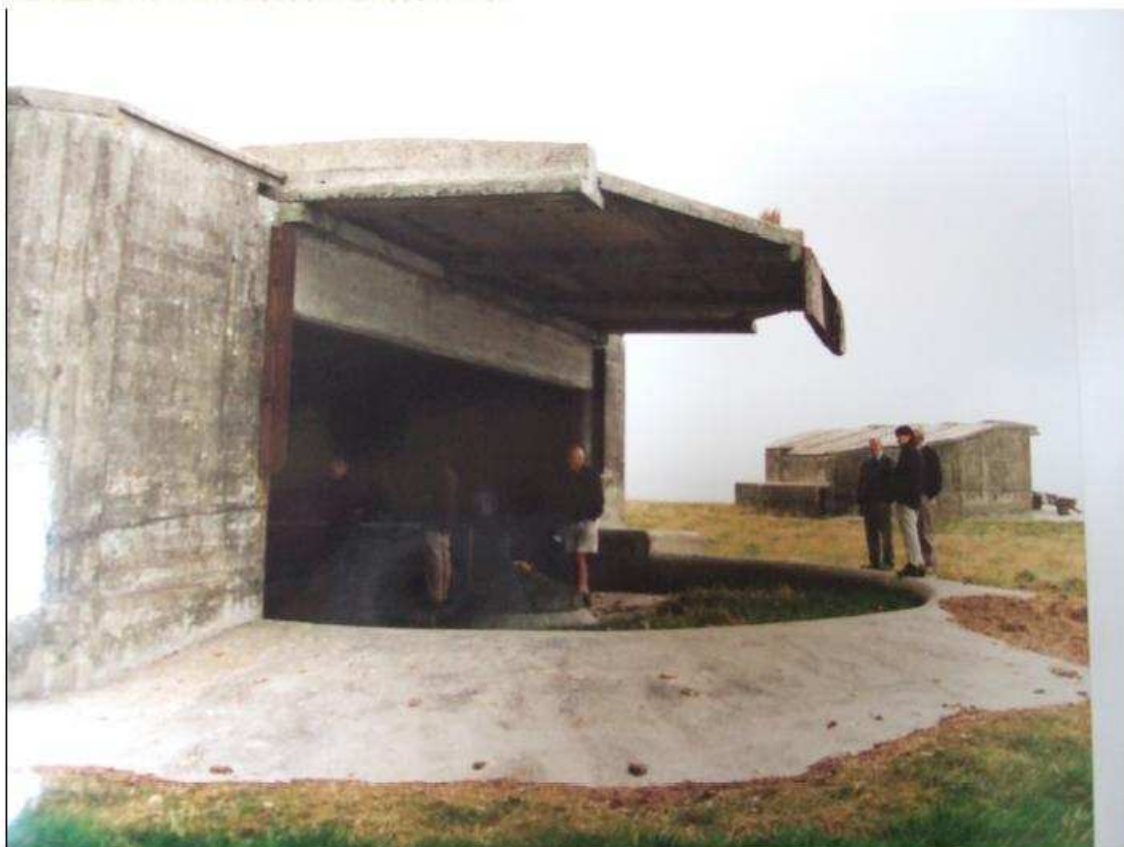
| Gun emplacement at Rerewahine, c. 1985. Condition of emplacements now is reportedly very poor. Photo provided by Laurie Stewart of the Otago Peninsula Trust and Fort Tairaroa Education and Resource Centre. | | | | |

Archaeologically, all concrete structures still remain in place, though these are in varying conditions. The site is on privately owned land, and the battery magazine has been modified in some capacity by the landowner (Cooke 2000: 496), while other structures have been utilised for the owners present business ventures (Stewart, L.: pers. comm.). Only one of the wooden barrack blocks is still standing (Cooke 2000: 496). Reportedly, many of the remaining concrete structures are in poor

condition, with the concrete deteriorating to such an extent as to make many of the structures unstable (Stewart, L.: pers. comm.). Due to the instability of the site and the resulting safety concerns, this site was inaccessible for survey as part of this project.

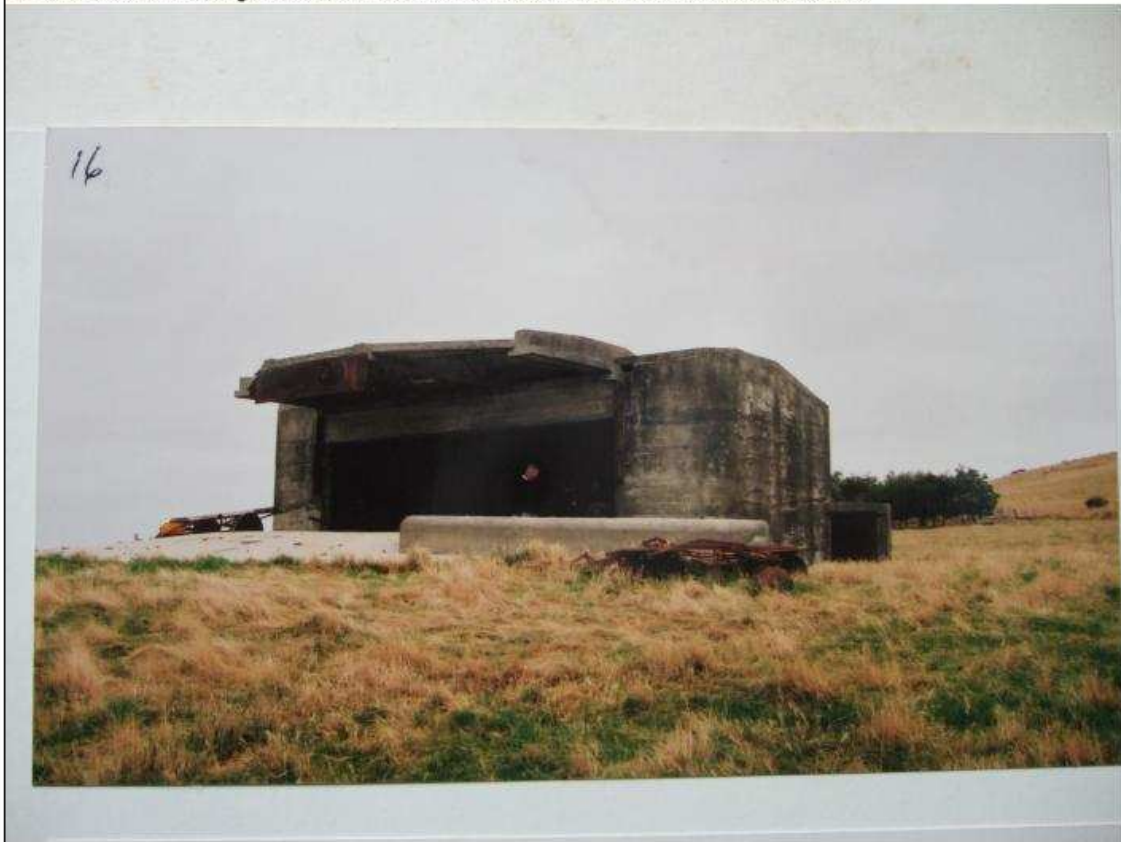
Gun emplacement at Rerewahine, c. 1985. Condition of emplacements now is reportedly very poor. Photo provided by Laurie Stewart of the Otago Peninsula Trust and Fort Tairaroa Education and Resource Centre.

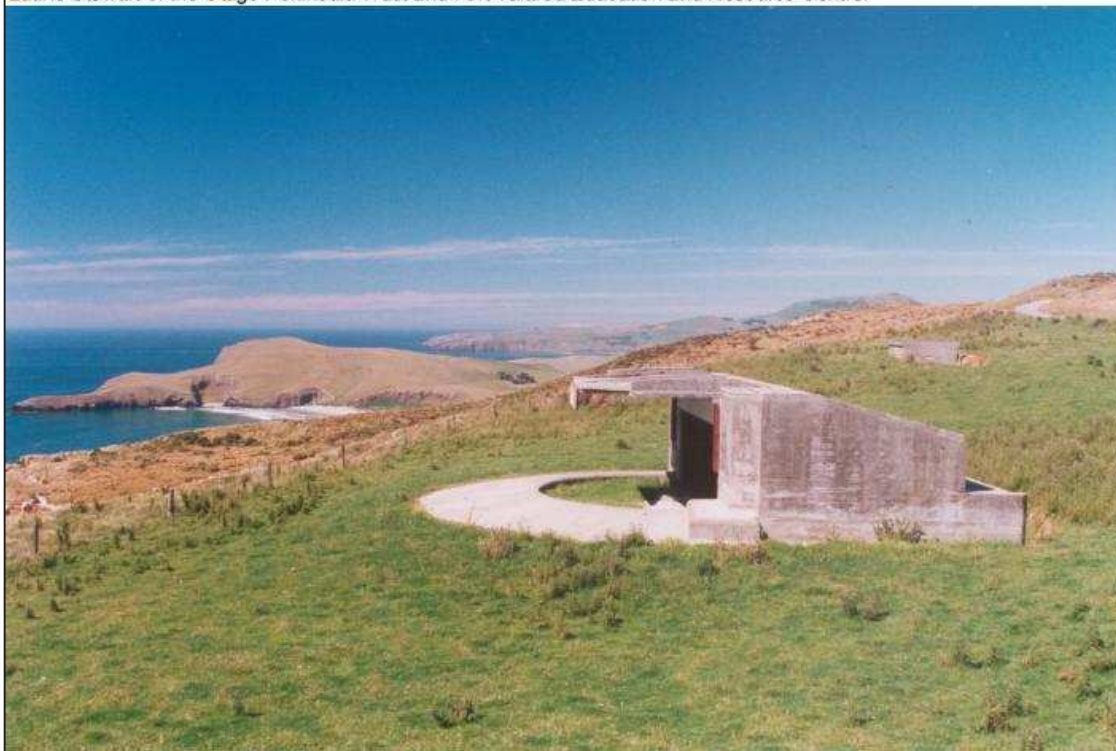
Gun emplacement at Rerewahine, c. 1985. Condition of emplacements now is reportedly very poor. Photo provided by Laurie Stewart of the Otago Peninsula Trust and Fort Taiaroa Education and Resource Centre.
